INVESTIGATION NUMBER T (8 6) E 0 1 7

EPA Region 9 TSCA Section 6 PCB Inspection Report

FACILITY NAME: General Dynamics Convair Division Plant 19

INSPECTION DATE: November 14-15, 1985

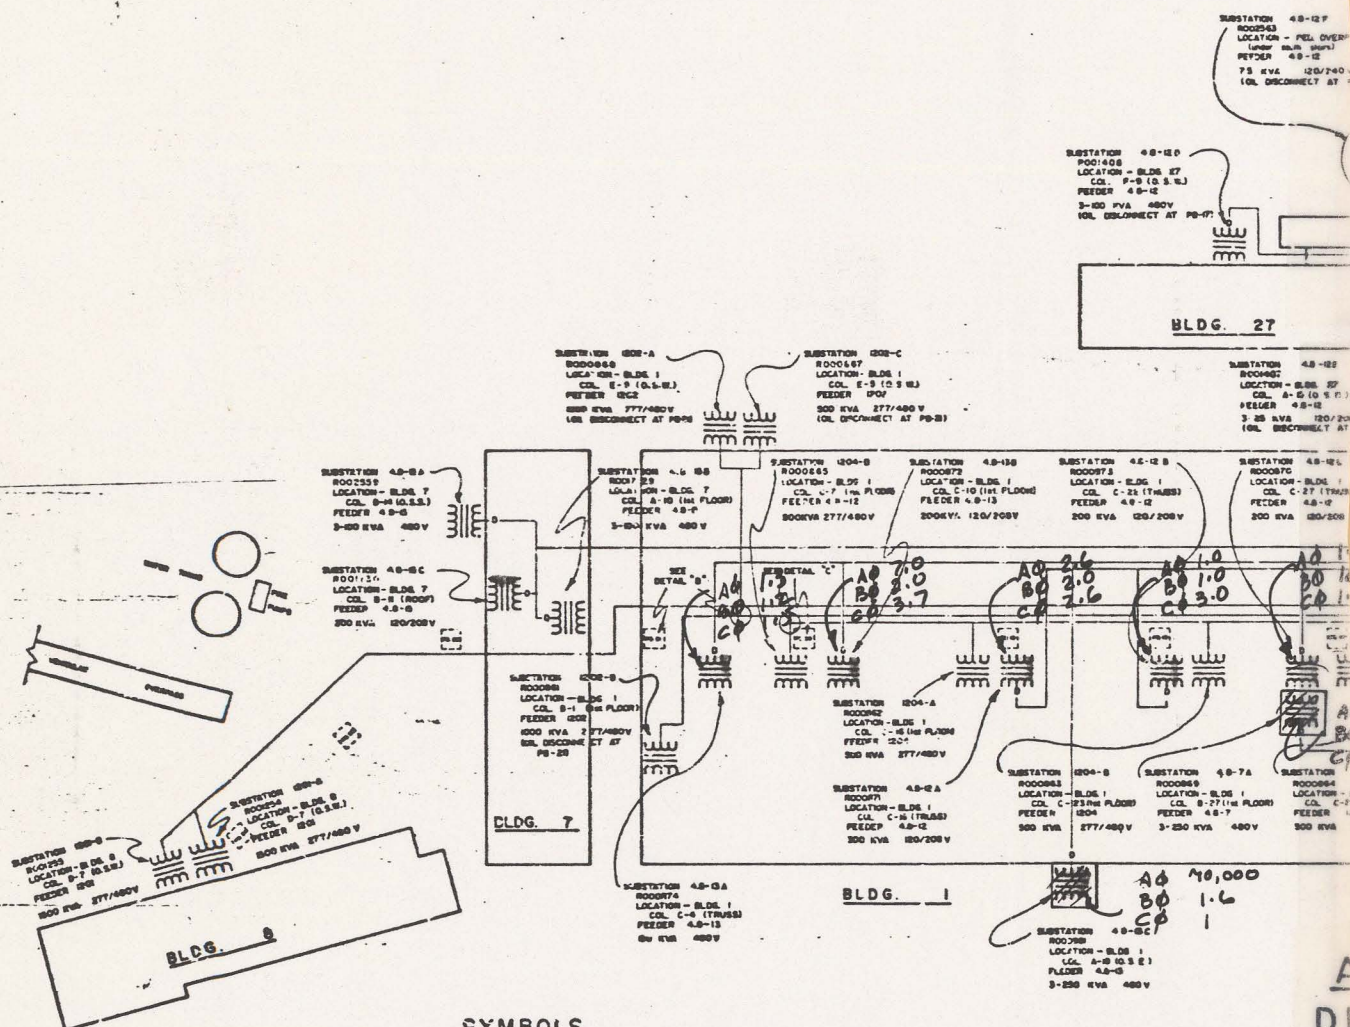
P.C.B. TRANSFORMERS. (REPLACEMENT FUNDING
RECEIVED FROM USAF. CONTRACT AWARDED.)

INDICATES OIL FUSED SWITCHES
(AMMOUNT OF PCB CONCENTRATION)

SWITCHES TO BE REPLACED
